# Improving the Reliability of Aluminothermic Welding

**Yoshihiro TERASHITA**

Assistant Senior Researcher, Rail Welding, Track Technology Division

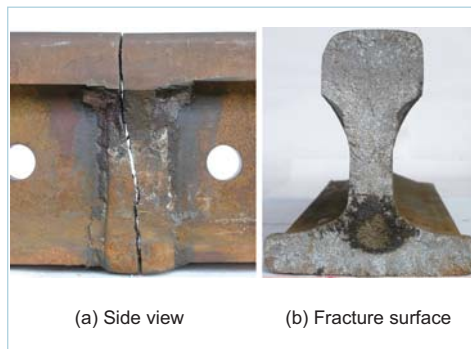
The aluminothermic welding method adopted in the JR group is the SkV method introduced from Germany in 1979, and in recent years about 25,000 welds per year have been executed. Figure.1 shows the number of aluminothermic welds executed on tracks within the JR group, the number of fractured welds and the causes of the fractures. Around 1988 when continuous welded rails began to be adopted on conventional lines, there was a rapid increase in the number of welds. However, fractures occurred at the base of the rails, and these were caused by lack of fusion. By introducing the application of ultrasonic inspection using the double-probe technique to detect the lack of fusion, the Railway Technical Research Institute (RTRI) succeeded in preventing the fractures. Measures were also taken to ensure that the welding process was carried out correctly, such as prescribing the adjustment method of preheating flames. However, fractures due to centerline shrinkage in the central part of the weld metal at the base of the rails occur almost every year, and measures to deal with this problem were requested. Figure.2 shows an example of the appearance and the fracture surface of an aluminothermic weld that has broken on a conventional line. The fracture occurred in the central part of the weld metal, and centerline shrinkage has been generated at the lower rail fillet, which was rusted in black.

Fig.2 Example of the appearance and the fracture surface at a broken aluminothermic weld

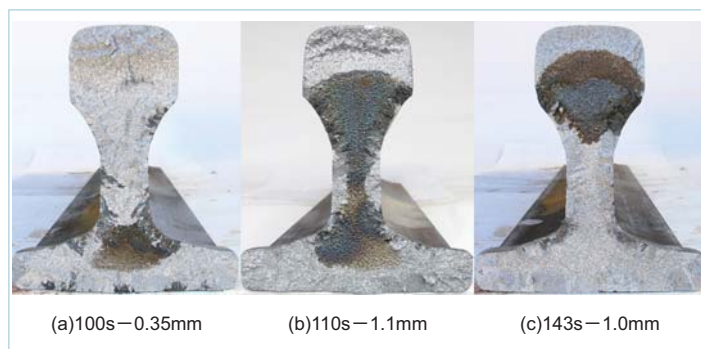
ure.3 shows the fracture surface of the centerline shrinkage which occurred under the conditions of a time of 100sec after pouring the molten steel into the mould, and the welded rail was shifted outwards by 0.35mm. The fracture surface pattern is similar to that shown in Fig.2 (b). Further, the locations where centerline shrinkage occurred and the area affected were different depending on the elapsed time from the pouring of molten aluminothermic steel to the shifting of the rails, and the amount by which the rails were shifted (Fig.3 (b), Fig.3 (c)). Even when the rail was shifted by 1 mm or more 90 sec after pouring the molten steel, when it is not yet in the final solidification stage, centerline shrinkage did not occur. Nor did centerline shrinkage occur 160 sec after pouring, when the solidification process had finished, again even when the rail was shifted by 1 mm or more. On the other hand, in the case of the rail being shifted 100 to 150 sec after pouring, centerline shrinkage occurred at many welds and the it was transferred from the base of the rail to the web and head in correlation with the passage of time from pouring of the molten steel (Fig.4). This is because the solidification of molten aluminothermic steel progresses from the base of the rail to the web and head. Sometimes, solidification at the lower rail fillet is delayed compared with solidification at the surface layer of the web (for example, Fig.3 (b)), and it is considered that the centerline shrinkage occurs only at the lower rail fillet depending on the timing and amount of the rail being shifted.

Fig.3 Example of fracture surfaces of the centerline shrinkage reproduced in a simulation test

Although we are not able to introduce it here, we are proposing ultrasonic inspection as the detection method for centerline shrinkage occurring at the lower rail fillet and at the base of the rail as well as its criteria for ultrasonic inspection. The remaining task is to propose a measure that prevents occurrence of centerline shrinkage beforehand, and we would like to continue making efforts to eliminate breakage of rails from aluminothermic welds.

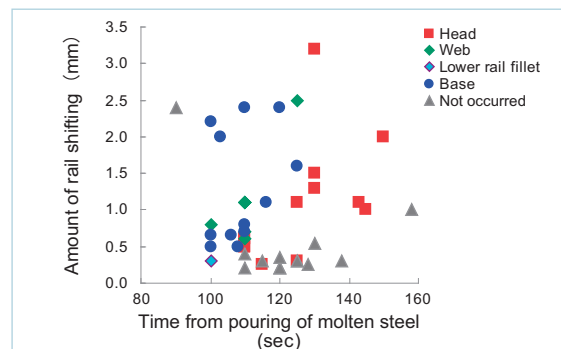
Fig.4 The relationship between the conditions and the affected area of centerline shrinkage occurrences
