RTRI Develops Wooden Sleeper Deterioration Evaluation System

The Railway Technical Research Institute (RTRI) developed Wooden Sleeper Deterioration Evaluation System based on a deep learning technique that uses images captured with a video camera installed on the front window of the leading car of a train running on, e.g., a commercial line. The system can automatically determine the degree of deterioration of wooden sleepers such as corrosion and cracking (Fig. 1). The system will enable wooden sleeper conditions to be determined even if track maintenance engineers do not go to the site and improve efficiency in determining the degree of deterioration of wooden sleepers, including increasing inspection speed, and saving labour and costs.

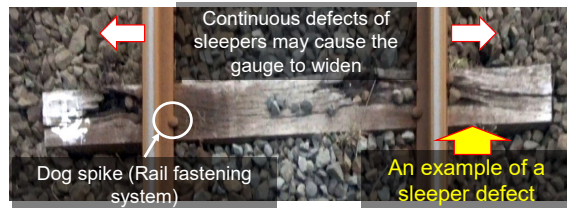
Fig. 2 An example of a sleeper defect

On sections of railway lines constructed mainly of wooden sleepers, successive defects of sleepers as shown in Fig. 2 may cause the rail fastening force to decrease and gauge to widen during travel, which can consequently cause derailment.

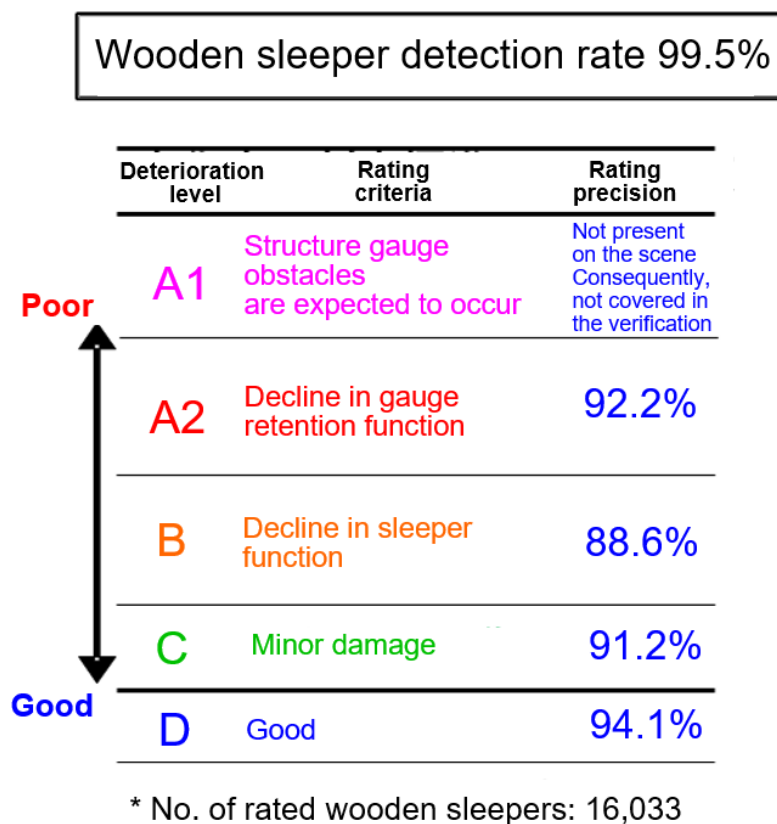
Fig. 3 Rating precision of this system

- The degree of deterioration is determined on four-level determination criteria. Our tests confirmed that the deterioration determined with this system was 90% or more identical to that visually assessed by track maintenance engineers (Fig. 3).
- Determination results can be verified with specialized software “Makuragi Viewer (Sleeper Viewer)” (Fig. 4) and can be output in the spreadsheet-style form of an inspection record book. With this viewer and record book, determination results for each sleeper can be output in a colour-coded format to denote the degree of deterioration,

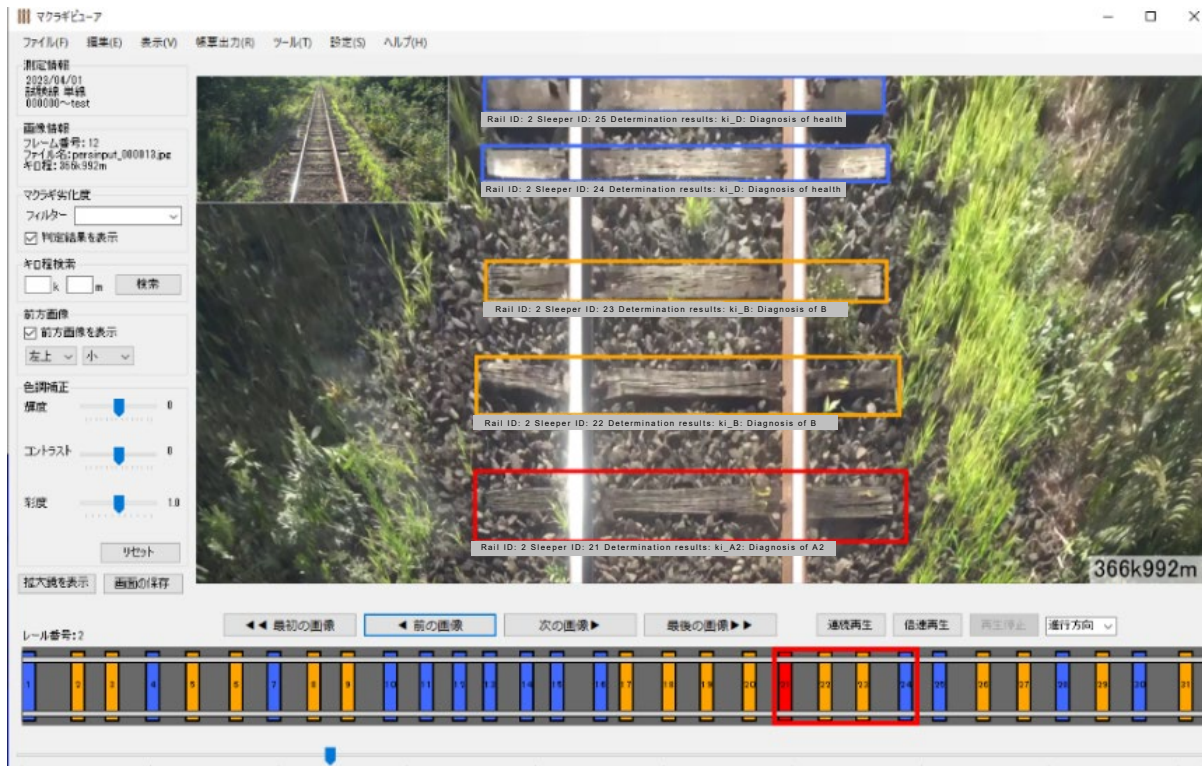
Fig. 4 Screen displaying determination results obtained from the Sleeper Viewer

making it easy to identify the degree of deterioration and areas where successive defects occur.

- Our Sleeper Viewers are equipped with functions to search kilometrage, enlarge images, measure lengths, and calculate angles, and therefore, the viewers can be used to determine the degree of deterioration of wooden sleepers, confirm conditions of given sleepers and rail fastening systems, and the like, as well as to measure tie spacing and right angle displacement (rotation of sleepers installed at right angles to rails) of sleepers.
