Newsletter on the Latest Technologies Developed by RTRI

Railway Technology Avalanche

January 1, 2005 No. 7

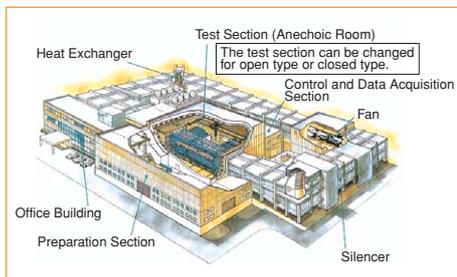
Figure 1. RTRI's large-scale low noise wind tunnel

RTRI's large-scale, low-noise wind tunnel was constructed for research on various aerodynamic and aeroacoustic issues for the Shinkansen and other high-speed railways. This wind tunnel has an open test section and a closed test section (Figs.1, 2), and has the following features (Table 1).

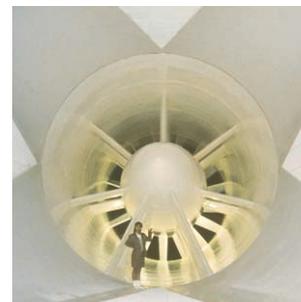
Figure 2. Fan

Overall dimensions	Length:94 m, Width:42 m, Height:10 m, Total path length:288 m	
Fan	Diameter:5 m, Blades:Moving blades:12, Stator blades:17 Rotation:590 rpm (Maximum), Traction motor:7MW, Three phase induction motor

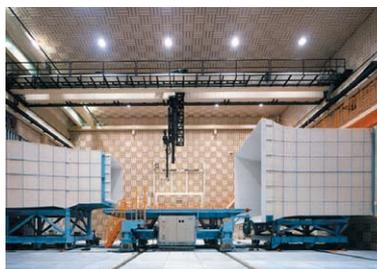
Figure 3. View of open test section

The open test section is chiefly used for testing aeroacoustic issues, such as the aerodynamic sound produced by a model. The cross-section of the nozzle is 3.0 m in width and 2.5 m in height, and the length of the test section is 8.0 m. The maximum wind velocity is 400 km/h. The model can be set on a support table (turntable) between the nozzle and the collector. This test section permits testing of an actual pantograph.

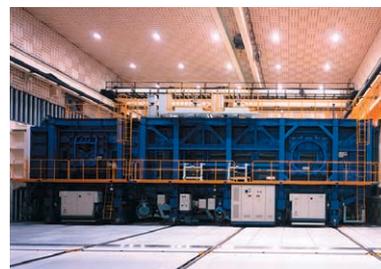
Figure 4. View of closed test section

The closed test section is used for testing aerodynamic issues, such as aerodynamic drag, the aerodynamic characteristics of the model, the flow around the model, and other issues. The closed test section is 5.0 m in width, 3.0 m in height, and 20 m in length. The closed test section is composed of a front part (6.5 m in length) and a rear part (13.5 m in length). The front part is equipped with a boundary suction system and a turntable with a 6-component balance, and the rear part with a boundary suction system, a moving belt ground plane, and a turntable. These two parts are joined together to form the test section. The maximum wind velocity is 300 km/h. This test section permits testing of an actual pantograph and an actual automobile.

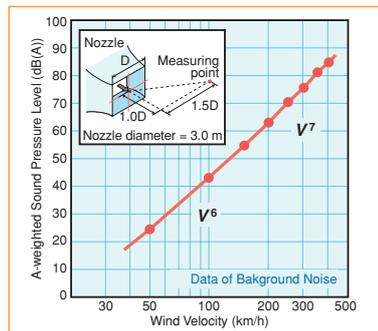
Figure 5. Background noise level

2. An extremely low background noise level 75.6 dB at wind velocity of 300 km/h (Fig. 5)

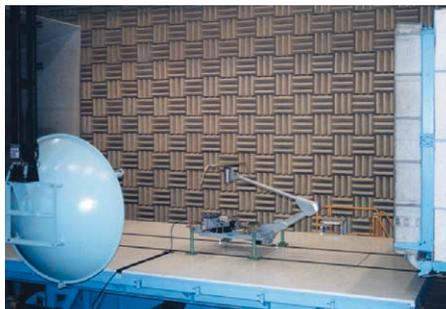
Figure 6. Aeroacoustic test of pantograph using ellipse microphone apparatus

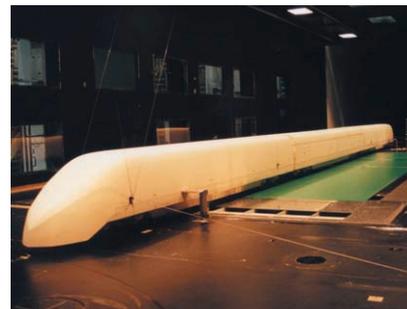
Figure 7. Vehicle model supported with 6-component wire balance

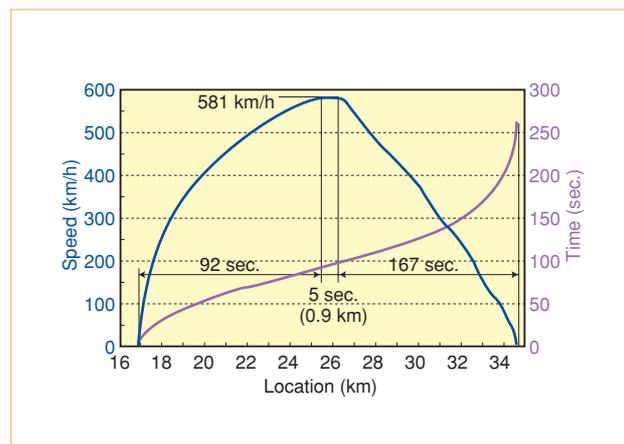
Figure 1. Running pattern during 581km/h test

Since the reliability of our system had been proved by a long period of stable running tests, we started the test with more confidence than we had five years ago when the maximum speed of 552 km/h was attained. On December 2, 2003, we twice recorded a top speed of 581 km/h (Figure 1). This speed is considered near the limit on the 18.4 km experimental line. However, since our maglev system boasts exceptional acceleration, we felt that it could easily break the new speed record of 581 km/h if the line were extended.

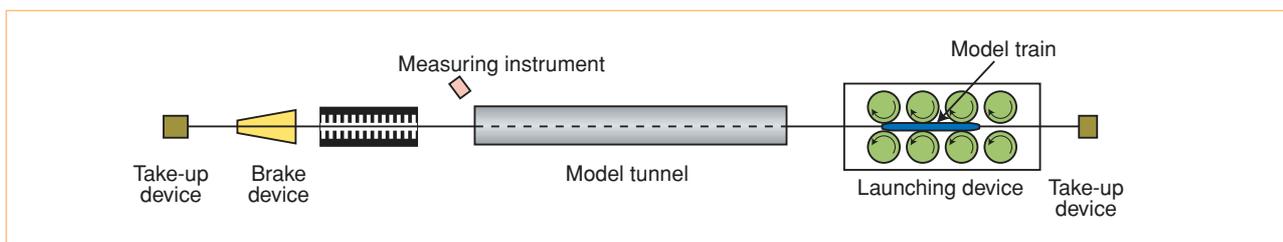
Figure 1. Scheme of model launching test apparatus

The model launching test apparatus is used to launch a model train at a very high speed for analysis of aerodynamic phenomena which occur when an actual train passes along an open space or rushes into a tunnel. It consists mainly of a launching device, a brake device and take-up devices (Figure 1). Although RTRI already had a test apparatus capable of launching a model at a maximum speed of 450 km/h, a new launching test apparatus capable of a higher speed became necessary for the development of high-speed railways of the 500 km/h class.

In order to make the model train run along a prescribed course, steel wire is stretched from the launching device to the brake device by the take-up device so that the model is guided by the steel wire.

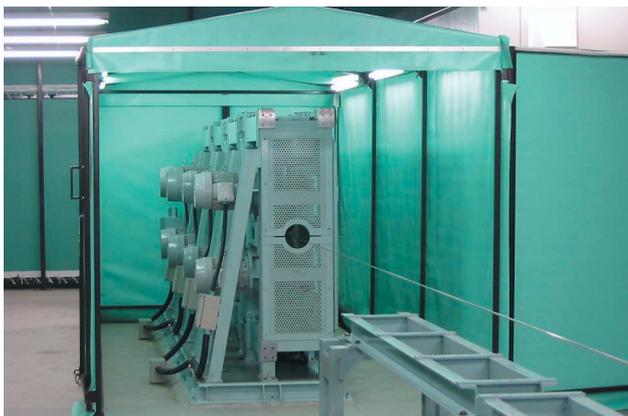
Figure 2. Launching device

The launching device consists of four pairs of upper and lower wheels (launching wheels), which are rotated at high speeds to send out the model train set in between. The cross-section shape of the rubber bonded to the rim of each launching wheel to obtain the force of friction with the model train surface was designed so that the rubber would not peel off due to the centrifugal force resulting from high speed rotations of the wheel. As the model train is sequentially pushed out by the four pairs of launching wheels, it is accelerated in stages. When the target speed is attained by the front-end pair of wheels, the model train is launched (Figure 2).

One of the most difficult challenges was how to allow the model train sent out by the launching device to reach the brake device 20 m ahead without causing it to slow down. The pushing force was determined by adjusting the axle-to-axle distance of launching wheels sandwiching the model train. In addition, the rotational speed of each individual launching wheel was adjusted. As a result, we were able to launch a model train at a speed exceeding 500 km/h. It was confirmed that the speed of the model train at the time when it reached the brake device 20 m ahead was 500 km/h. The brake device could stop the model whose mass was some 600 grams without being damaged.

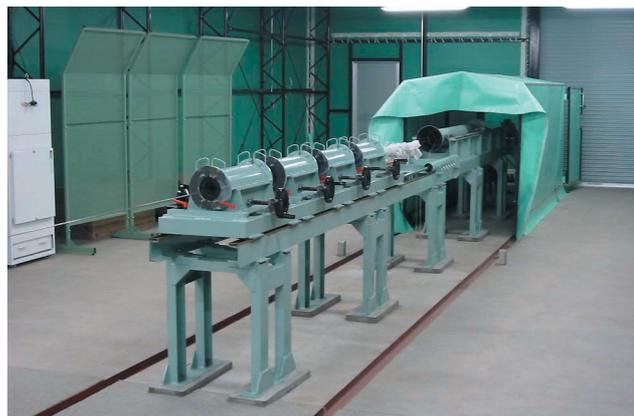
Figure 3. Brake device

The brake device consists of a cylinder lined with a laminated plate of rubber sheets. As the model train passes through the cylinder, it is decelerated by the friction between its surface and the rubber lining till it stops. The

main braking apparatus is about 3 m in length and capable of completely stopping the rapidly running model train within the section. This braking apparatus is provided with another braking apparatus with cushion toward its front (Figure 3).

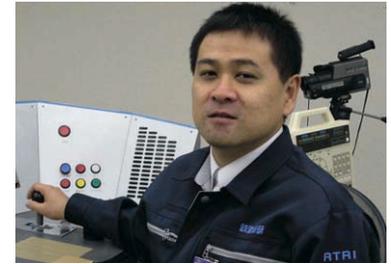
Figure 1. View of experiment using blind persons as subjects

Under that condition, we, the members of the Study Committee for Improvement of TGSIs (Chairman: Osamu Sueda, professor at The University of Tokushima, Secretariat: the Foundation for Promoting Personal Mobility and Ecological Transportation), carried out various experimental studies (Figure 1). The main items studied are outlined below.

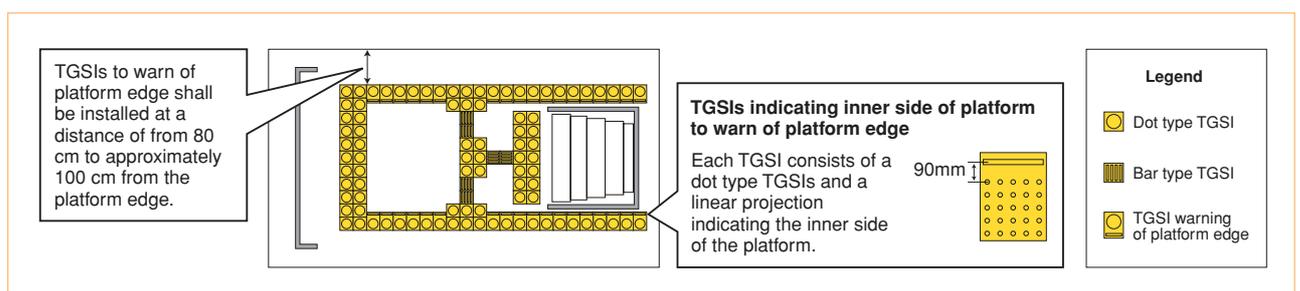
Figure 2. TSGI to warn of platform edge

There was the only rule concerning the position of installation of TGSIs to warn of the platform edge: "They shall be installed at a distance of at least 80 cm from the platform edge." Because of this, the actual installation position was different from one station to another. Therefore, the unification of installation positions has been called for. On the basis of the results of our experiments, we concluded that TGSIs to warn of the platform edge should be installed at a distance of from 80 cm to approximately 100 cm from the platform edge (Figure 2).

To warn of the edges of platforms, dot type TGSIs have been commonly used. With these TGSIs, however, although blind people notice that they are near the platform edge by means of dot type TGSIs, they often fail to discriminate the inner side of the platform from the outer side. This is because conventional TGSIs have only symmetrical raised dot patterns, which do not give information about direction. We therefore developed a new TSGI indicating the inner side of the railway platform by means of a linear projection added inside each dot type TSGI, and whose width has been increased in view of the study result mentioned in (1) (Figure 2). The linear and dot projection conforms to JIS standards and the new TSGI has been included in the above guidelines as a TSGI to warn of the platform edge.

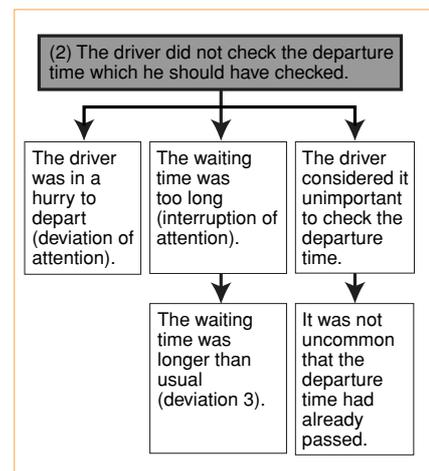
The second step—investigation of causes of deviations—is to reason the causes of the individual deviations clarified in the first step and the origins of those causes. In this step of analysis, we apply a cause-down analysis approach whereby the causes of the deviations are determined by a successive series of questions (Figure 1). For the purpose of this analysis, we also prepared a "human factor guide" which tabulates a chain of interrelated human factors to help reason out the causes of deviations involving those human factors.

Figure 1. Example of cause-down analysis using "human factor guide" (only part of map is shown)
