Detection of Concrete Exfoliation by Active Infrared Thermography

Hisashi TANAKA

Assistant Senior Researcher, Concrete Structures, Structures Technology Division

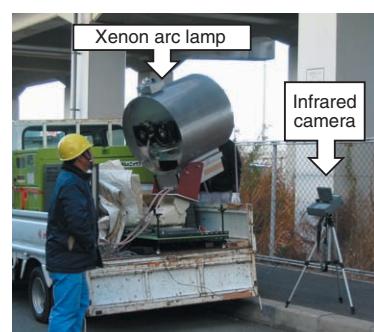
Figure 4. Inspection vehicle

With the aim of confirming the applicability of the method to actual viaducts, a special inspection vehicle (Fig. 4) was prepared and a field test was carried out by using it (Fig. 5). Examples of the infrared images obtained are shown in Fig. 6. In the passive infrared thermographic image before irradiation by the xenon arc lamp (Fig. 6 (a)), several high-temperature parts which were considered due to exfoliation were observed. In the active infrared thermographic image after irradiation by the xenon arc lamp (Fig. 6 (b)), the exfoliated parts that were observed in the passive infrared thermographic image were observed more clearly. In addition, a high-temperature part which could not be observed in Fig. 6 (a) could be observed in Fig. 6 (b) (the part that is indicated by an arrow). From these results, it was confirmed that active infrared thermography permits detecting concrete exfoliation more accurately than passive infrared thermography. In the future, we have plans to study a technique to judge the soundness of concrete covering using detection results.
