Development of Earthquake Resistant Bridge Abutment (Reinforced with Cement-Mixed Earth)

Tateyama, Masaru

Senior Researcher, Laboratory Head, Foundation & Geotechnical Engineering, Structures Technology Division

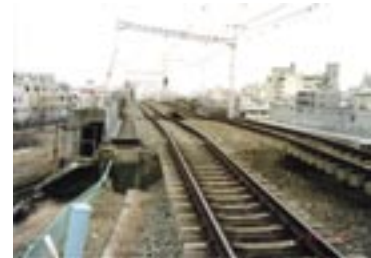
Figure 2. A damaged bridge abutment at Hyogoken-Nambu Earthquake (January 17, 1995).

Figure 2 shows the settlement behind a bridge abutment seen after the Hyogoken-Nambu Earthquake that attacked the southern part of Hyogo Prefecture, Japan, when large degrees of settlement were observed along the entire routes in the area. Under the circumstances, thorough measures have been required to effect sufficient earthquake resistance at earthquakes of such a large magnitude. In conjunction with the Japan Railway Construction Corporation and the University of Tokyo, therefore, we performed vibration tests of various bridge abutment types, based on which we proposed a new reasonable abutment structure with earthquake resistance high enough to keep the structure stable.

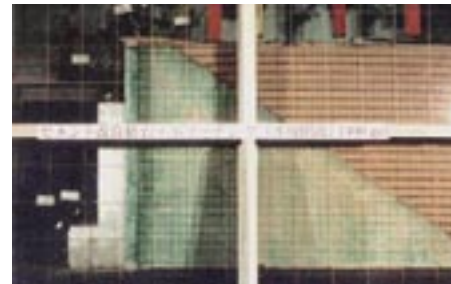
Figure 4. Deformation of the model abutment after a shaking test.

To check the earthquake resistance of the bridge abutment reinforced with cement-mixed earth, we performed a series of vibration tests of a model and a bridge beam at the scale ratio $\lambda = 1/10$, by using the medium-scale vibration table of the Railway Technical Research Institute (RTRI), for about 40 cases of different measures and exciting waveforms. Figure 4 shows the model abutment after excited under an irregular wave at 1,400 gal. It virtually did not deform in this high-frequency vibration test, but exhibited extremely high earthquake resistance even when compared with the case where the conventional measure was applied and tested under the same condition.

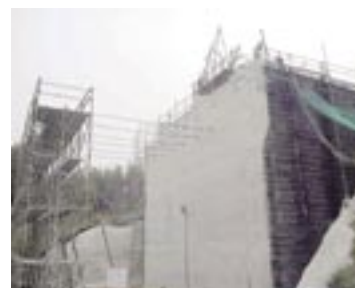
Figure 6. View of the lateral loading test in Kyushu.

We performed a lateral loading test of the bridge abutment by applying 4,000 kN or the design load for large-scale earthquakes to prove that it has extremely high-level earthquake resistance, in that the displacement is as small as 15 mm. See Fig. 6 for a test scene. This bridge abutment will be used for projected Shinkansen lines as the standard structure.
