Tunnel Scanning System Using Image Processing To Detect Lining Deformations

Masato UKAI

Senior Researcher, Signaling Systems, Signaling & Telecommunications Technology Division

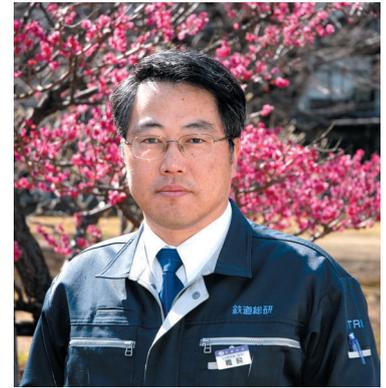
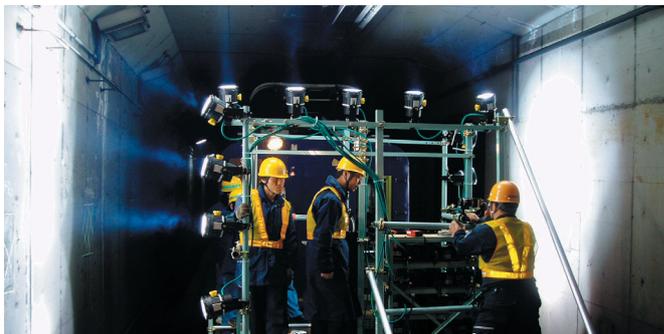
Fig.1. Tunnel-scanner system for tunnel wall image recording.

We have developed an efficient tunnel scanner with line sensor cameras capable of taking high-precision panoramic annular images of the surface of a tunnel lining, at a low cost (see Fig. 1). The system does not require a special vehicle, but instead can be mounted on a railcar used for construction or maintenance purposes. Photographic equipment is basic, consisting of cameras, lights, control devices and the like. The 5,000 pixel line sensor cameras are mounted on the railcar and aimed at the tunnel walls. The railcar travels at a speed of 10 to 30 km/h, and can take images of the surfaces of a single-track tunnel with just one run. A double-track tunnel requires two runs, one on each track to obtain images of the entire section. Continual image taking is possible for dozens of kilometers per run. Basically, only the image taking and recording is done on the railcar, with off-line processing of image data being performed above ground. Our new system performs far better than a conventional photographic system, in terms of filming speed, recording time and memory. The resolution is the same as the number of camera pixels for cross-sectional directions, but depends on the running speed and scan rate for longitudinal directions. Under ordinary circumstances, the pixel pitch setting is around 0.8 mm horizontal/vertical.
