RTRI Develops Automated Visual Inspection System for Vehicle Underbody

The Railway Technical Research Institute (RTRI) has developed an automated visual inspection system that captures images of the underbody of passing railway vehicles and diagnoses any external abnormalities.

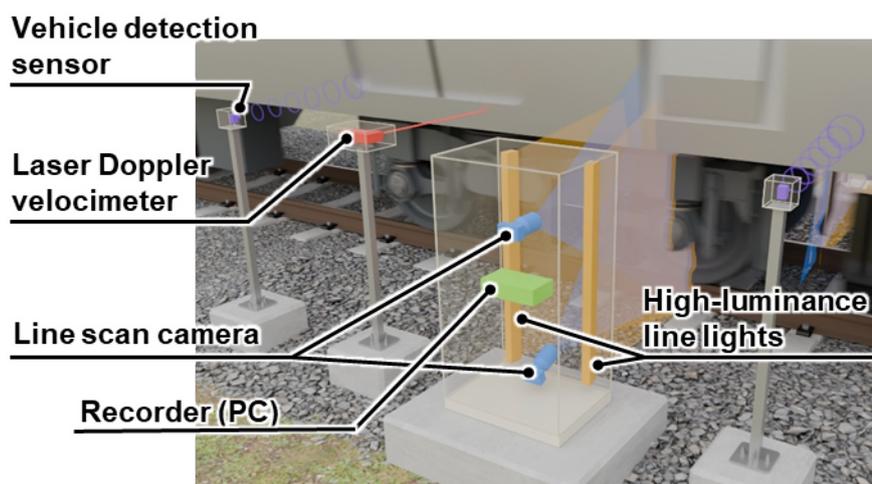
- The imaging device consists of a line scan camera, high-luminance line lights, a laser Doppler velocimeter, a vehicle detection sensor, and other components (Figure 1), and it can capture and store high-resolution images of the underbody of passing vehicles outdoors, regardless of the time of day or weather conditions.

Figure 1 Conceptual layout of the imaging device

By installing the imaging device (Figure 2) at the entrance of the depot, side views of the underbody are captured as trains enter the depot. In this system, the line scan camera captures images while the laser Doppler velocimeter measures the passing speed of the vehicle (Figure 1), thereby providing continuous images (Figure 3).

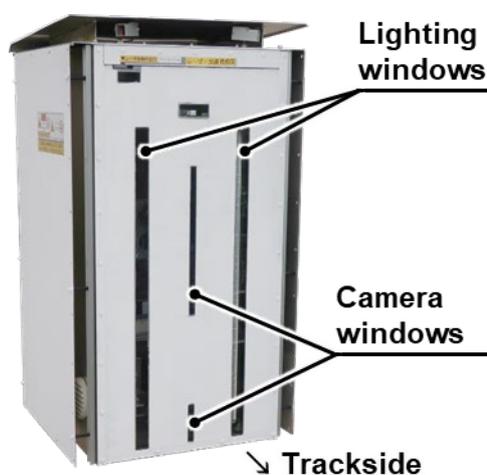
Figure 2 Imaging device

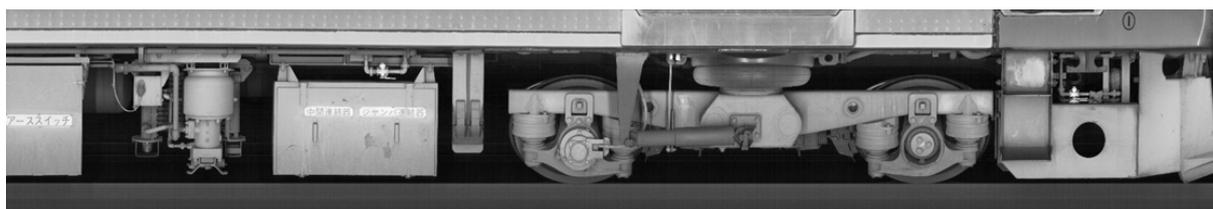
Figure 3 Example of an image captured by the system

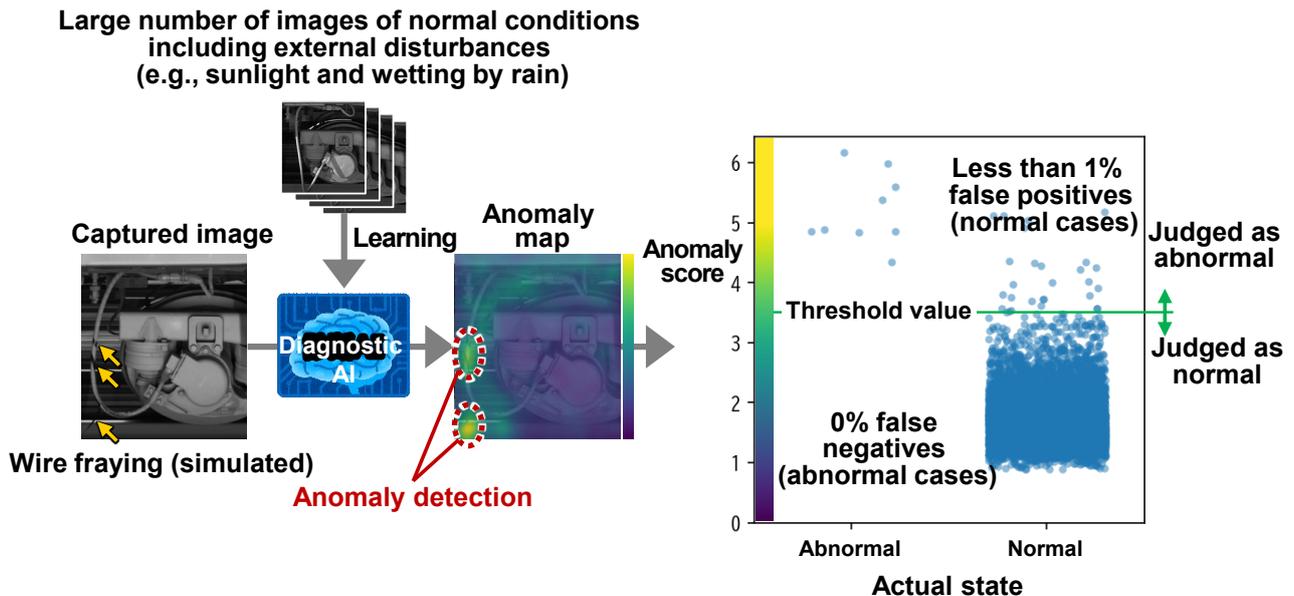
Figure 4 Diagnostic algorithm and verification results (diagnosis of wire fraying)

Based on the vehicle identification numbers recognized from the captured images, the system diagnoses the exterior condition of individual vehicles using an algorithm that employs vehicle-specific template images and AI models trained for each vehicle type. In the diagnosis, while suppressing the influence of appearance changes at the inspection points caused by external factors such as sunlight or wetting by rain, the system calculates an anomaly score for each inspection point by combining AI trained on a large number of images of normal conditions with an algorithm that evaluates differences from the normal images, and determines whether each inspection point is normal or abnormal by comparing the score with a threshold value (Figure 4).

As a result of verification by imaging vehicles running in the depot over a period of one year and nine months, it was confirmed that the system can diagnose 15 types of simulated abnormalities (Table 1) with accuracies of 0% false negatives (abnormal cases judged as normal) and less than 1% false positives (normal cases judged as abnormal). This indicates that approximately 70% of the underbody areas that have conventionally been inspected visually in train inspections can be replaced by automated inspection using this system.
