Estimation of Lateral Resistance of Ballasted Track during Seismicity

Takahisa NAKAMURA

Assistant Senior Researcher, Track Structures and Geotechnology, Track Technology Division

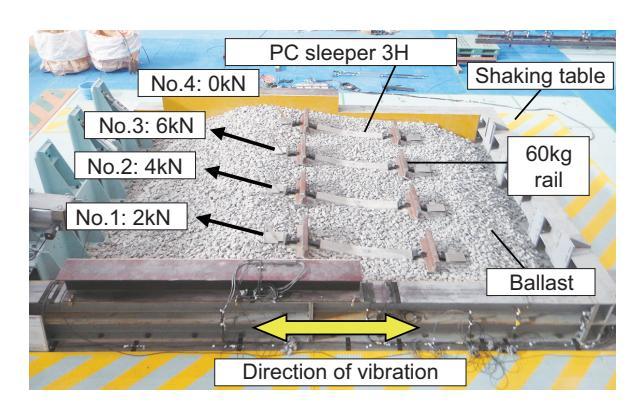
Fig. 1 Status of Large-scale Shaking Table test (sloped (with cant))

This test assumed a ballasted track of a typical crosssectional shape for Shinkansen on a viaduct. The test configuration consisted of four sets of mockups placed on a shaking table, and each set includes one full-scale sleeper tested at a time (Fig. 1). Two track configurations were simulated: curved track simulated with a superelevation (cant) of 200 mm and straight track simulated with no superelevation. To estimate the ballast lateral resistance during vibration, we used a spring attached to each sleeper and applied tensile loads while measuring sleeper displacements. We also performed a lateral ballast resistance test before and after sinusoidal vibration (input acceleration of 800 gal) and estimated the ballast lateral resistance before and after vibration. (1 gal = 0.01 m/s².)

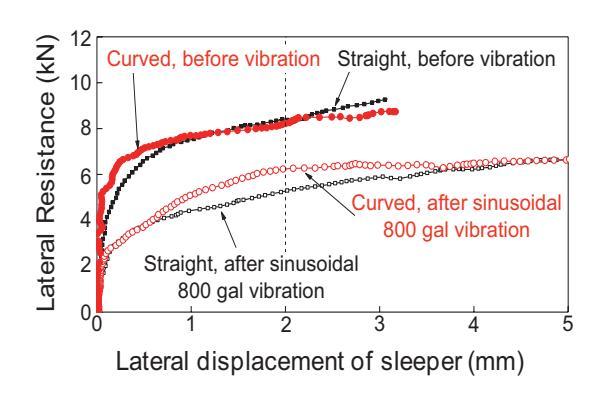
Fig. 2 Lateral resistance before and after 800 gal vibration

Fig.2 shows the relationship between the lateral resistance before and after sinusoidal 800 gal vibration. The lateral resistance declined after vibration regardless of the ballast shapes, i.e., curved or straight track simulation. Fig.3 shows the

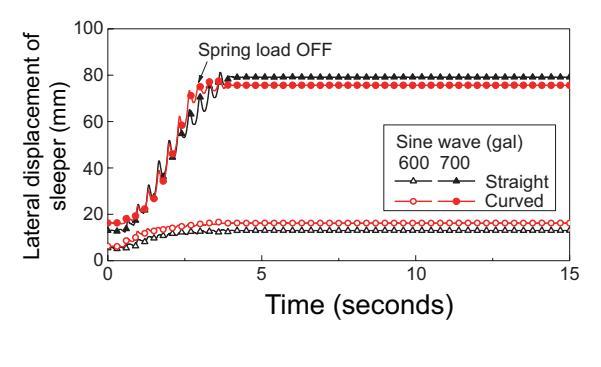
Fig. 3 Sleeper displacements during vibration (Straight: Tensile load 4 kN)

horizontal displacements of the sleeper measured when a tensile load of 4 kN was applied during vibration. The horizontal displacement of the sleeper increased abruptly during sinusoidal 700 gal vibration regardless of the ballast shapes. It has become clear from these tests that even if a tensile load during vibration is smaller than the maximum ballast lateral resistance after vibration, a large residual displacement is induced during vibration. The test results have also indicated that the geometric difference of ballasts has little effect on the lateral resistance before, during and after vibration.
